# Bow Lake | Shoreline Survey Results

**TO:** Lisa Murphy, Strafford Regional Planning Commission  
**FROM:** Mindee Goodrum, FB Environmental Associates  
**SUBJECT:** **Bow Lake Shoreline Survey Results**  
**DATE:** September 29, 2026  
**CC:** Tim Kirsten, FB Environmental Associates

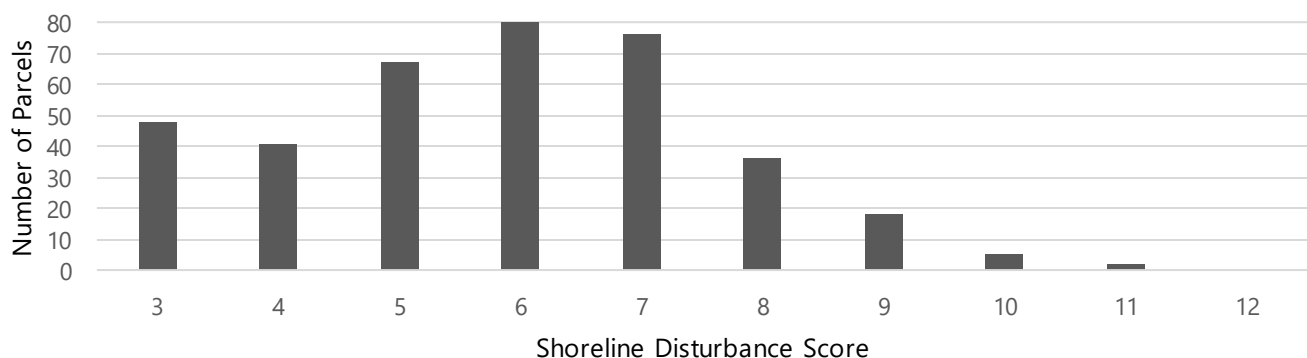
A total of 375 parcels were evaluated along the shoreline of Bow Lake in Strafford and Northwood, NH. The average Shoreline Disturbance Score (based on vegetated buffers, amount of bare soil, and visible shoreline erosion) for the entire study area was 5.84 (Table 1). About 37% of the shoreline (or 137 parcels) scored 7 or greater (Figure 1). A disturbance score of 7 or above indicates shoreline conditions that may be detrimental to lake water quality. These shoreline properties tended to have inadequate buffers, evidence of bare soil or use of lawn fertilizer, and shoreline erosion. The average Shoreline Vulnerability Score (based on structure distance and slope of the land) was 3.50 (Table 1). About 60% (or 226 parcels) scored 4 or greater (Figure 2). A vulnerability score of 4 or greater indicates that the parcel may have a home less than 150 feet from the shoreline and a moderate or steep slope to the shoreline. Parcels with a vulnerability score of 4 or greater are more prone to erosion issues whether or not adequate buffers and soil coverage practices are maintained. Many parcels are particularly prone to erosion for having a house close to the shoreline, with 177 parcels (47%) having a house within 75 feet of the shoreline. In summary, the overall average shoreline condition of Bow Lake is relatively good (average

disturbance score below 6), but it is on the borderline of poor conditions with an average shoreline disturbance of 5.84. Improvements can be made with 137 properties (37%) needing to address erosion or runoff issues that are impacting the lake. Refer to the end of this document for a map of the scores by parcel.

**Figure 1.** Histogram showing the number of parcels by Shoreline Disturbance Score for Bow Lake. The possible range of Shoreline Disturbance Scores is 3-12.

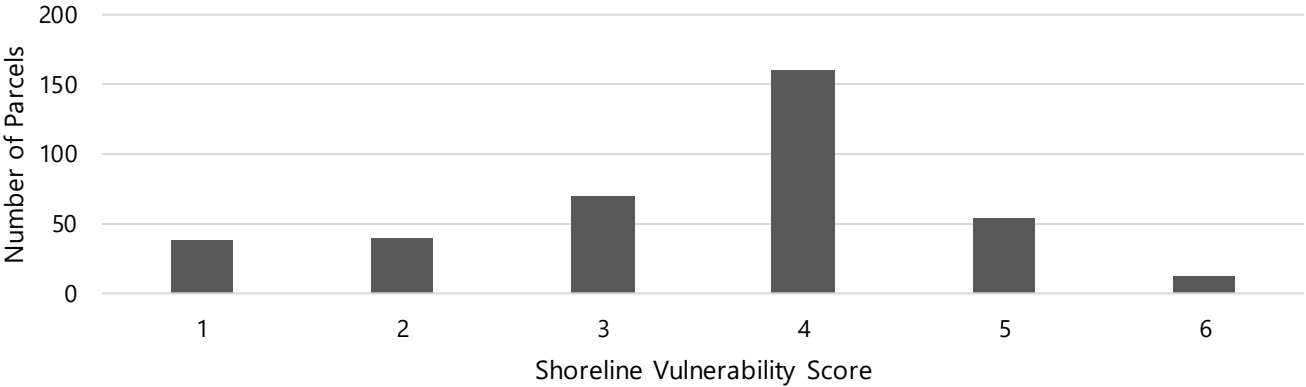
**Figure 2.** Histogram showing the number of parcels by Shoreline Vulnerability Score for Bow Lake. The possible range of Shoreline Vulnerability Scores is 1-6.

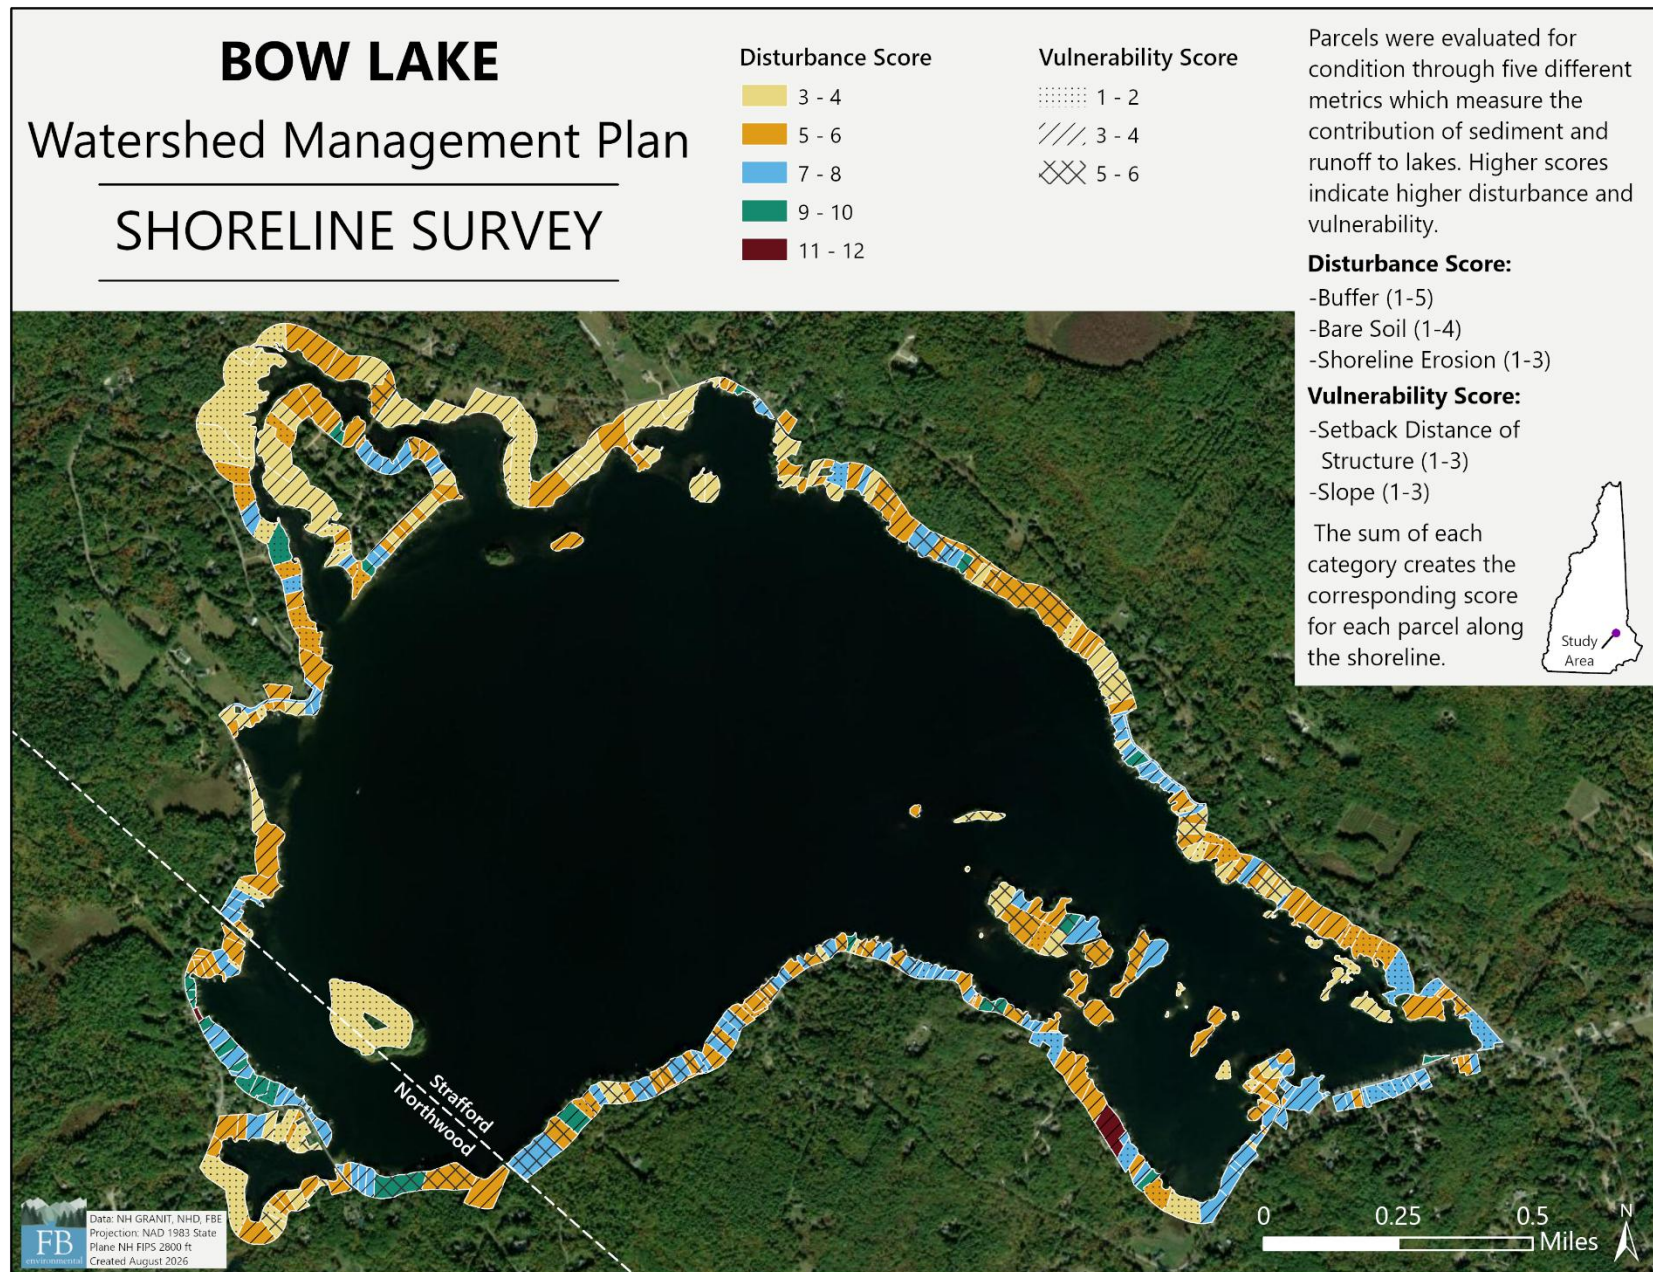
**Map 1.** Map of shoreline survey results for the shoreland zone of each parcel (within 250 feet of the lake).

The information obtained from this survey will be used to plan next steps for improving the shoreline of Bow Lake and further inform the watershed management plan. The survey map and database highlight areas that are possibly contributing to polluted runoff, and the shoreline scores should be used to prioritize areas of the shoreline for remediation. Educating neighbors and leading by example is a great way to help each other maintain the shoreline in its current state and prevent any future negative impacts shoreline properties may have on the lake. We recommend that the Bow Lake Master Plan Committee continues to monitor for lack of buffers, bare soil, and shoreline erosion, and to work collaboratively with landowners to provide educational resources and work together.

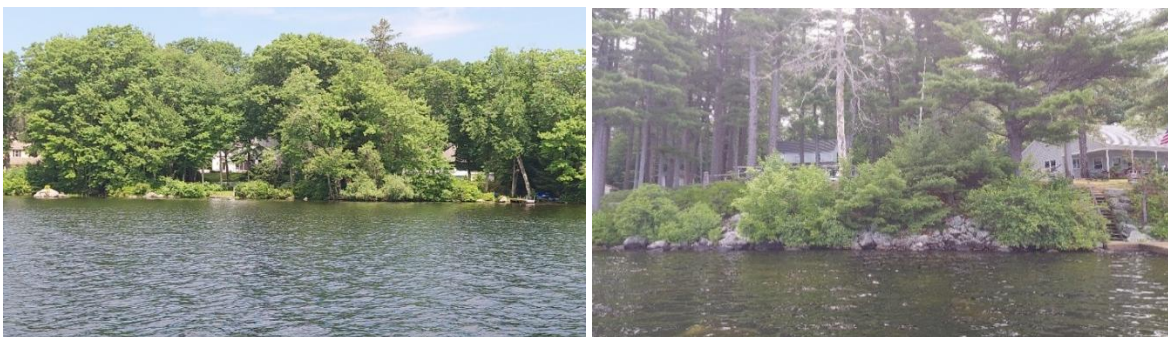
*Examples of shoreline properties with well-vegetated buffers consisting of multi-story canopies (trees and shrubs) and minimal exposed soil.*

Recommendations include reducing residential stormwater runoff and improving shoreline vegetated buffers. Homeowners should employ stormwater SCMs to infiltrate stormwater runoff prior to reaching the waterfront area of their properties. One of the best actions each shoreline homeowner can take is to look at their own property while it is raining to see where water flows. SCMs may include rain gardens, water bars, drip lines, and more. Refer to the [New Hampshire Soak up the Rain Program](#) for examples of stormwater infiltration practices and instructions for installation. The goal is to infiltrate stormwater rather than letting it flow across the surface and into the lake. The committee should also encourage landowners to plant and/or maintain vegetated buffers as an SCM along their shoreline, particularly in areas of bare soil. This will help stabilize the shoreline, mitigate erosion, and reduce sediment and nutrient loading to the lake. Landowners should be encouraged to revegetate their shoreline buffers with native plants, avoid large grassy lawns, increase mower blade height to 4 inches, and avoid bringing in sand to replenish beaches. Woody vegetation with deep rooting structures stabilizes banks and intercepts water flow, allowing it to spread out, slow down, and be filtered by the soil. [Native shrubs](#) planted along the shoreline such as blueberry, willows, elderberry, viburnums, dogwoods, winterberry, buttonbush, pepperbush, serviceberry, swamp azalea, and leatherleaf are great options. Digging small holes for shrubs and plants along the shoreline represents minimal temporary impacts from exposed soil and is therefore consistent with DES guidelines for shorefront protection and management guidelines. Many of these species can also be planted as live stakes with minimal ground disturbance.
